# Pavement Condition

## Common Distress Factors

The following pages describe the more common pavement distresses and well as shows an example of each. The streets in Dallas were checked for these conditions as well as a few others. Not all of our streets will have these distresses and some can have multiple in the same area.

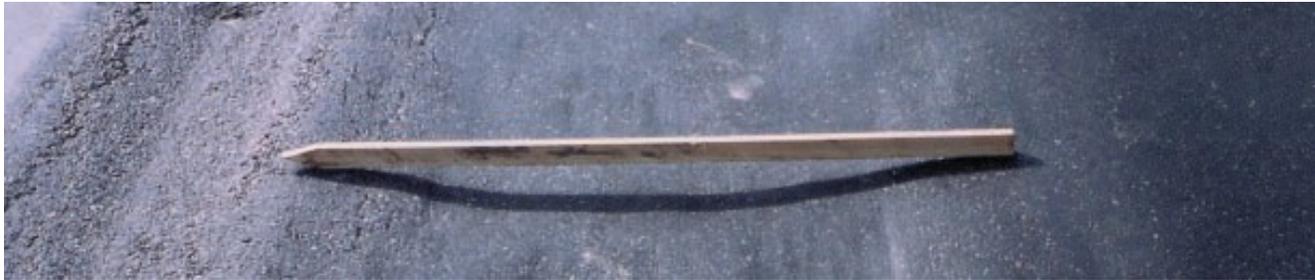
## Rutting

Rutting is a surface depression within the wheel path. Rutting results from a permanent deformation in any of the pavement layers or subgrades, usually caused by consolidation or lateral movement of the materials due to traffic loads. When the upper pavement layers are severely rutted, the pavement along the edges of the rutted area may be raised. Usually, the rutting occurs gradually across the wheel path, reaching a maximum depth in the center of the wheel path. Ruts are most obvious after rainfall when they are full of water.

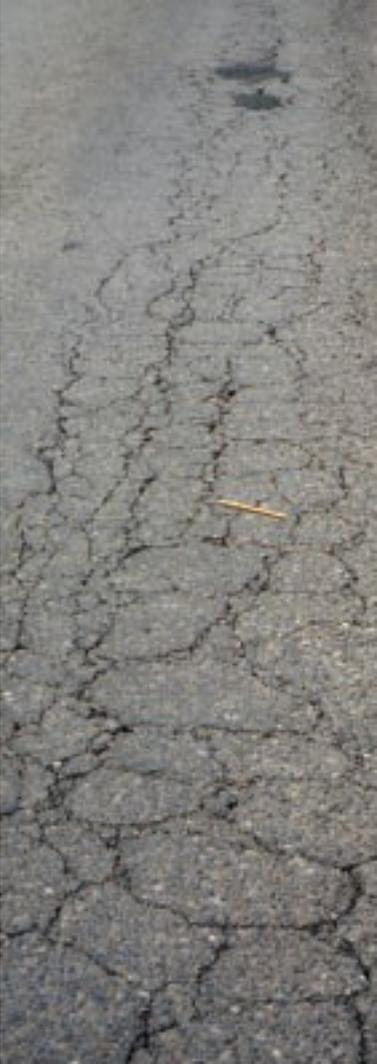
# Alligator Cracking

Alligator fatigue cracking is associated with loads and is usually limited to areas of repeated traffic loading. The cracks surface initially as a series of parallel longitudinal cracks within the wheel path that progresses with time and loads to a more branched pattern that begins to interconnect. The stage at which several discontinuous longitudinal cracks begin to interconnect, is defined as alligator cracking. Eventually the cracks interconnect sufficiently to form many pieces, resembling the pattern of an alligator.

On narrow, two-lane roads, alligator cracking may form along the center line rather than in the customary wheel paths.

Almost always, the pattern of the cracking (the longer dimension of the connected cracks) is parallel to the roadway or direction of vehicle travel. However, alligator cracking occasionally occurs in a pattern transverse to the roadway direction because of poor trench compaction, settlement, or frost action.

Pot holes and other occurrences of destroyed or missing pavement are accumulated as high severity alligator cracking and may also be noted in the comments area of the field form.

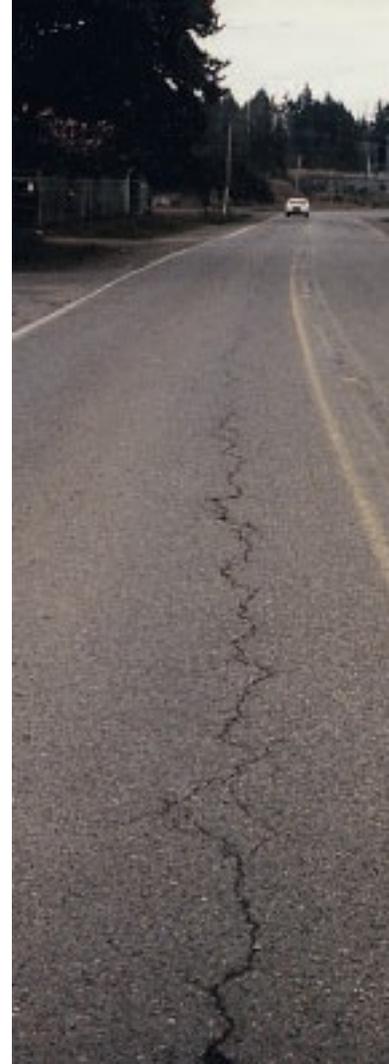
## Longitudinal Cracking

Longitudinal cracks run roughly parallel to the roadway center line. Longitudinal cracks associated with the beginning of alligator cracking are generally discontinuous, broken, and occur in the wheel path. However, any longitudinal crack that is clearly within the wheel path should be rated.

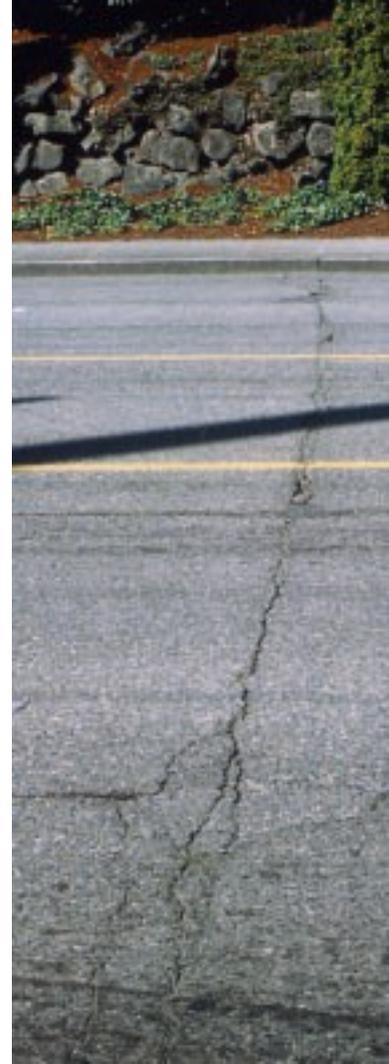
## Transverse Cracking

Transverse cracks run roughly perpendicular to the roadway center line. They may be caused by surface shrinkage due to low temperatures, hardening of the asphalt, or cracks in underlying pavement layers. They may extend partially or fully across the roadway.

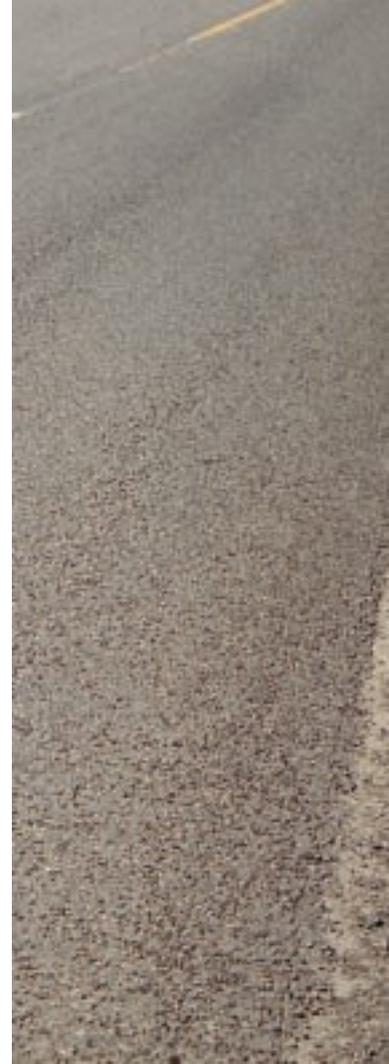
## Raveling and Aging

Raveling and aging are pavement surface deterioration that occurs when aggregate particles are dislodged (raveling) or oxidation causes loss of the asphalt binder (aging). An asphalt concrete pavement loses its smooth surface and begins to appear very open and rough.

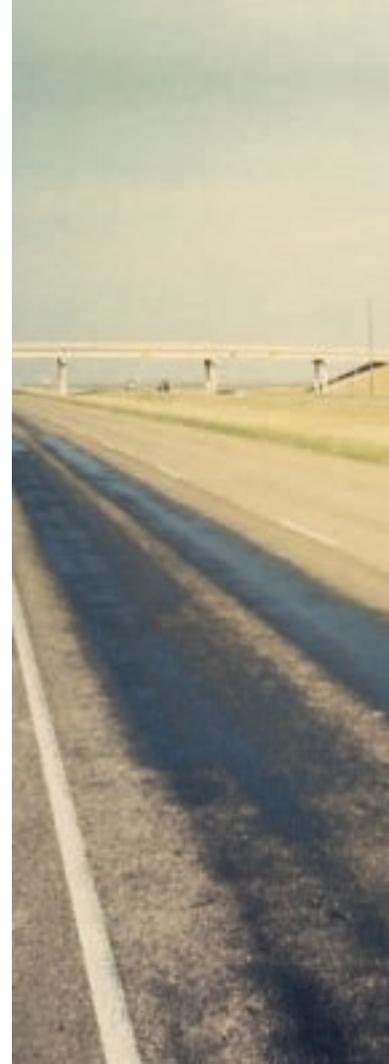
## Bleeding

Bleeding is indicated by an excess of bituminous material on the pavement surface which presents a shiny, glass-like reflective surface that may become sticky in hot temperatures.

At the lower severity levels, the extents “localized” and “wheel path” may be difficult to differentiate; however, as the severity increases, “wheel path” becomes better defined. Wheel path refers to tire tracking area and may be used to represent the condition of only one wheel track being heavily involved.

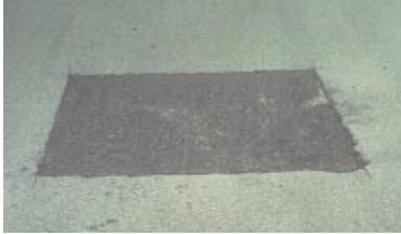
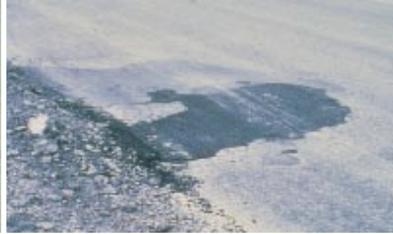
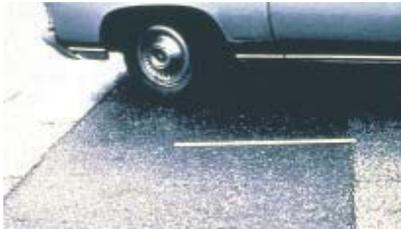
## Patching

A patch is an area of pavement which has been replaced with new material to repair the existing pavement or access the utility.

A patch is considered a defect no matter how well it is performing (a patched area or adjacent area usually does not perform as well as an original pavement section).

Generally, some roughness is associated with this distress. In general, a patch is less than a typical rehabilitation in size and scope. They are less than full roadway width and/or are less than project length. Some agencies may have patches as long as the work defined by another agency as a rehabilitation.

Temporary patches, as well as localized permanent repairs (dig-out repair), are included in this distress category. Utility cut patches are also included as part of the patching values.

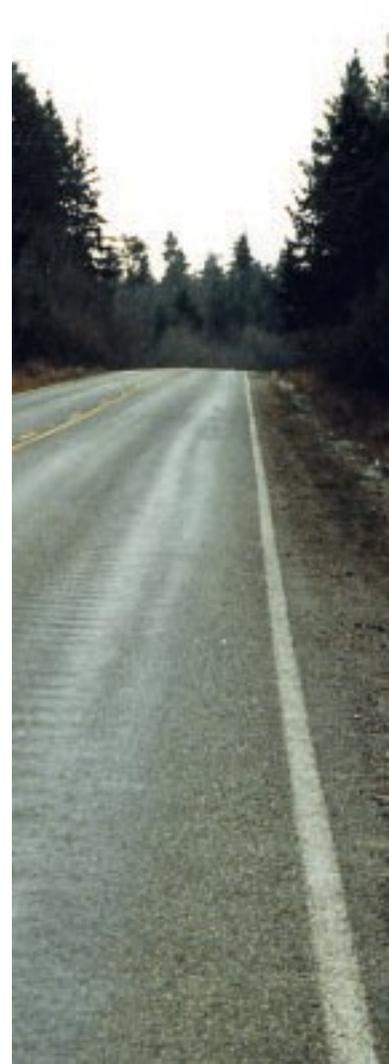
## Corrugation and Waves

This distress category covers a general form of surface distress which is not limited to the wheel path, although they may occur in the wheel path. The distress may occur in isolated areas, such as at intersections, or it may occur over a large part of the roadway surface.

Corrugations and waves are regularly occurring transverse undulations in the pavement surface. Corrugations occur as closely spaced ripples, while waves are undulations whose distance from peak to valley is more than 3 feet.

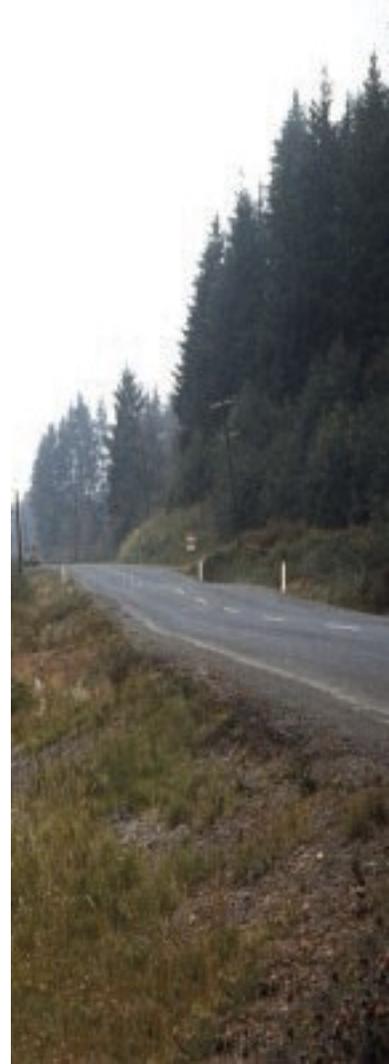
## Sags and Humps

This distress category also covers forms of surface distress that are not limited to the wheel path, although they generally include the wheel paths. The distress usually occurs in isolated areas of the roadway surface.

Sags and humps are localized depressions or elevated areas of the pavement that result from settlement, pavement shoving, displacement due to subgrade swelling, or displacement due to tree roots.

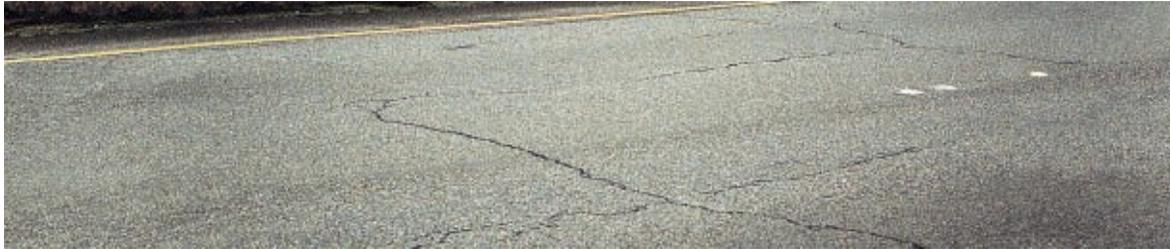
## Block Cracking

Block cracks divide the pavement surface into nearly rectangular pieces with cracks that intersect at about 90 degrees. This type of distress differs from alligator cracking in that alligator cracks form smaller, irregular shaped pieces with sharp angles. Also, alligator cracks are caused by repeated traffic loadings and are, therefore, generally located in traffic areas (i.e., the wheel paths).

Block cracking is caused principally by shrinkage of the asphalt concrete and daily temperature cycling. It is not load-associated, although load can increase the severity of individual cracks. The occurrence of block cracking usually indicates that the asphalt has hardened significantly through aging. Block cracking normally occurs over a large portion of the pavement area including non-traffic areas. However, various fatigue related defects may occur in the same segment.

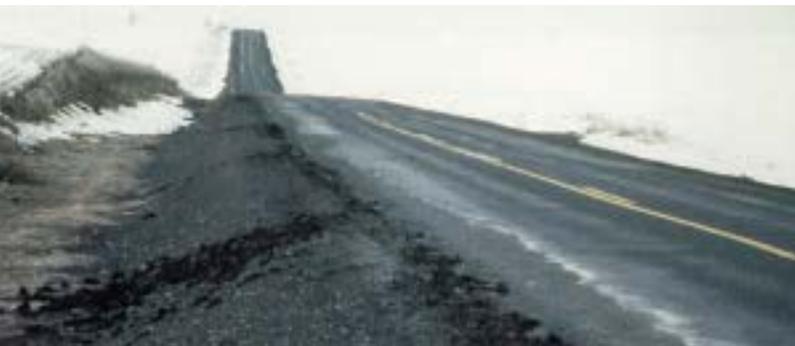
*Edge Raveling*

Edge raveling occurs when the pavement edge breaks away from roadways without curbs or paved shoulders. However, edge conditions can still occur with paved shoulders. Edge patching is the repair of this condition. The “lane less than 10 feet” distress indicates that the edge raveling has progressed to the point where the pavement width from the center line to the outer edge of roadway has been reduced to less than 10 feet.
